Manhole Inspection Summary

Manhole # S4100_001MH

Location Address: **1100 BONOPARTE AVE**

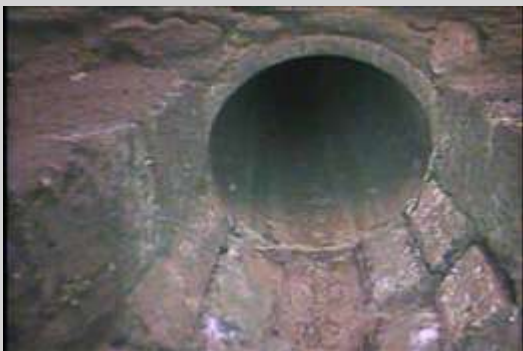
8 in. Circular Gravity Sewer Pipe In @ 3 O'Clock

Pipe Material: **Clay** ☐ Pipe Lined

Invert Depth: **7.19** (ft.) Flow Characteristics: **Slow**

Deposits: ☒ None ☐ Mud ☐ Sludge ☐ Debris ☐ Grease

Infiltration: **None** Pipe Seal Cond: **Unknown**
